INVENTORY OF MONUMENTS AT PAGAN

Volume One
Monuments 1-255

PIERRE PICHARD

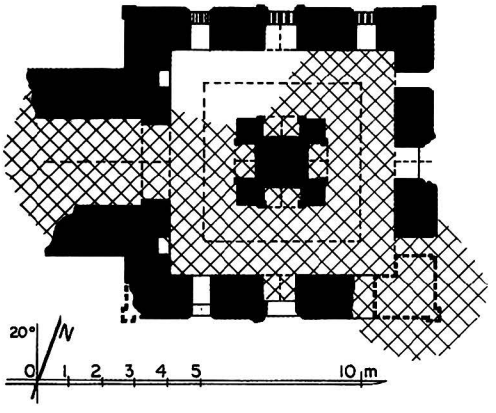
1784 a - Plan

5 present condition
- ruined.
- west porch and entrance hall collapsed.
- vaults of corridor collapsed, except over north-west corner.
- upper parts nearly destroyed.
- ground floor buried under debris.

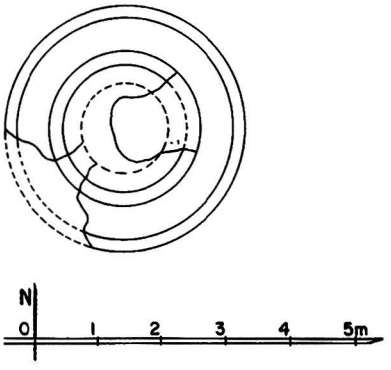
1785 a - Plan

5 present condition
- base disintegrated.
- upper parts damaged.

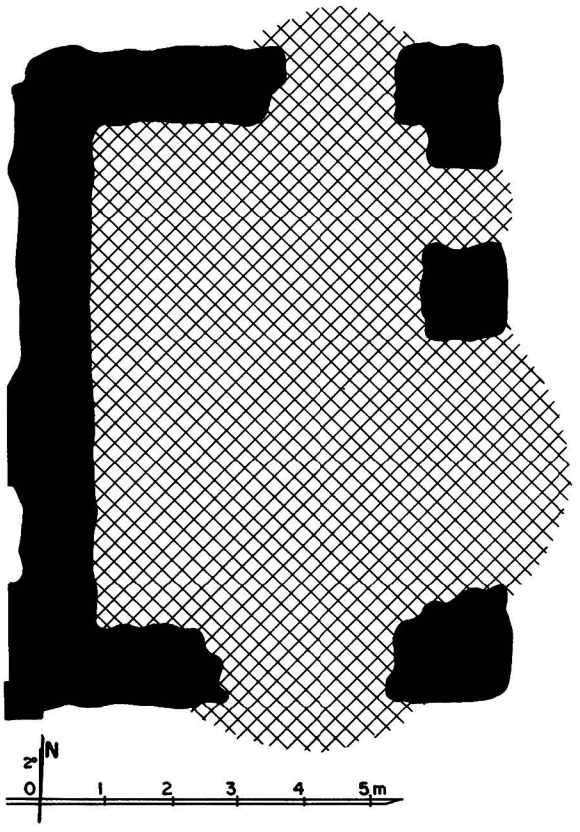
1786 a - Plan

5 present condition
- ruined.
- only base of walls remains.
- ground floor buried under debris.

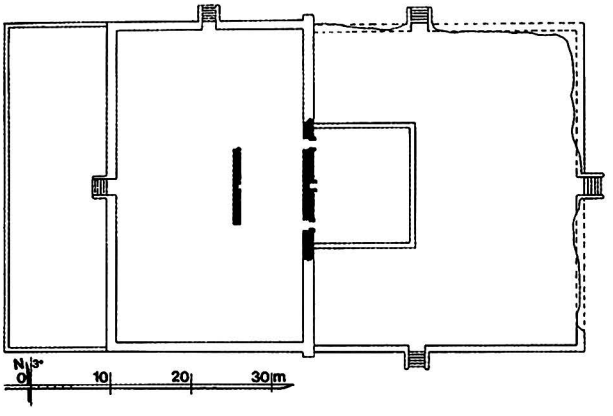
1787 a - Plan

5 present condition
- ruined.
- only platform and parts of east walls remain.

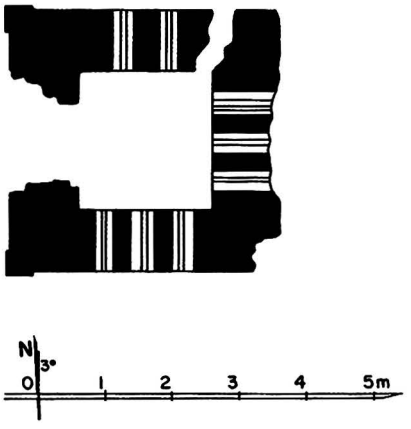
1788 a - Plan

5 present condition
- ruined.
- vaults and upper parts collapsed.
- ground floor cleared of debris.

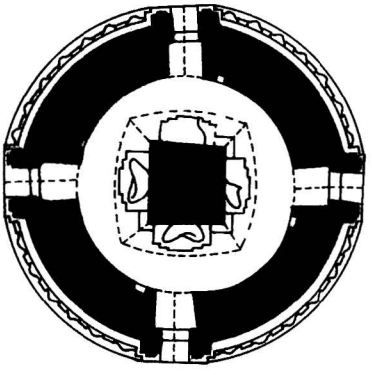
1790 a - Plan

5 present condition
- maintained.
- spire nearly destroyed.
- repaired (Arch. Dept.).

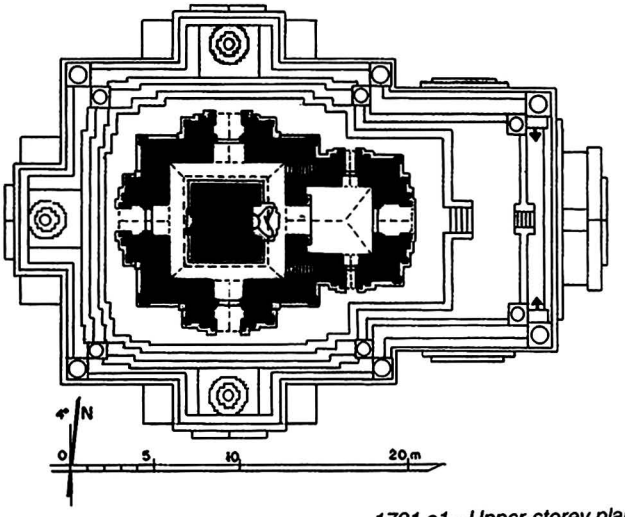
1791 a1 - Upper-storey plan

5 present condition
- regularly maintained.
- repaired and strengthened (Const. Corp.) 1981-82, with financial assistance by the German Government.

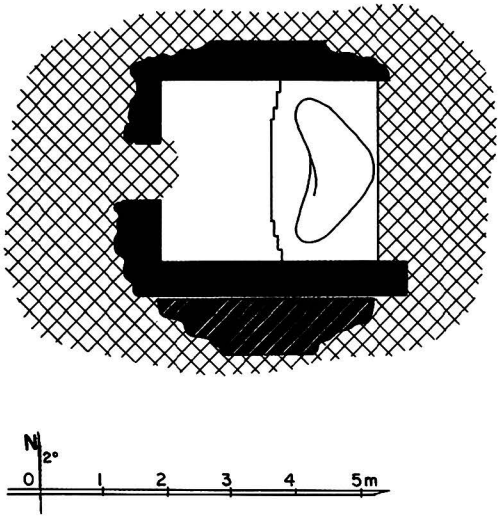
1792 a - Plan

5 present condition
- ruined.
- only base of walls remains.
- ground floor cleared of debris.
- masonry addition along south wall.

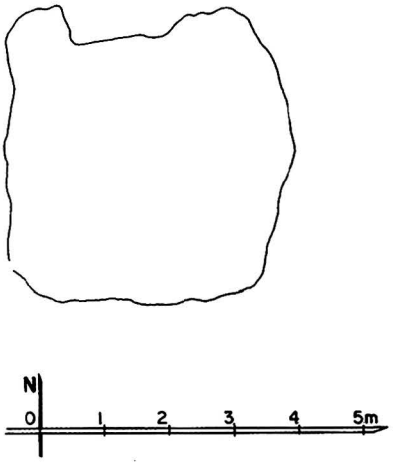
1794 a - Plan

5 present condition
- ruined.
- terraces disintegrated.
- upper parts destroyed.

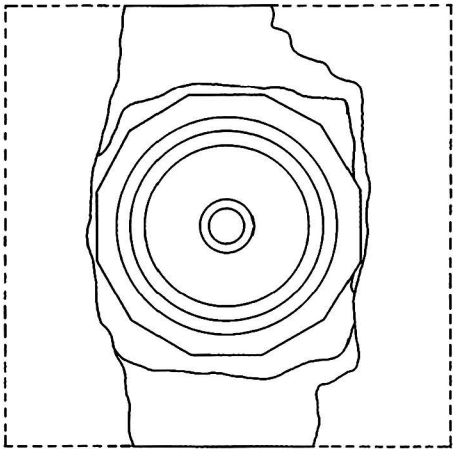
1795 a - Plan

5 present condition
- half-ruined and endangered.
- base and terraces disintegrated.

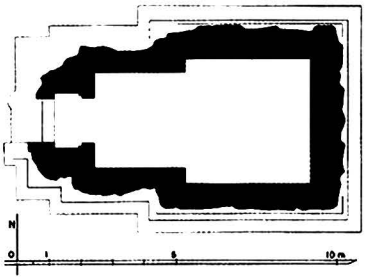
1796 a - Plan

5 present condition
- ruined.
- only base of walls remains.
- present height 2.10 m.
- excavated and repaired (Arch. Dept.) 1994.

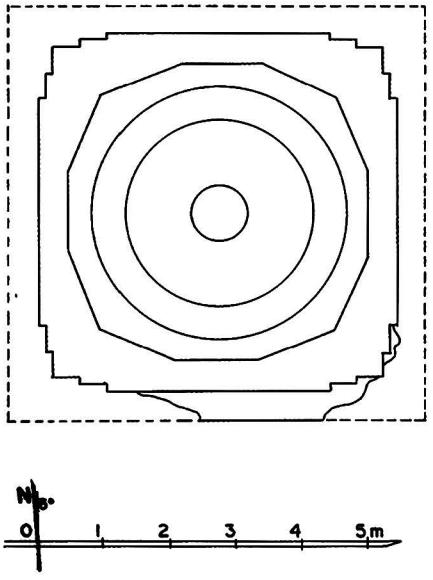
1797 a - Plan

5 present condition
- no maintenance.
- base disintegrated.

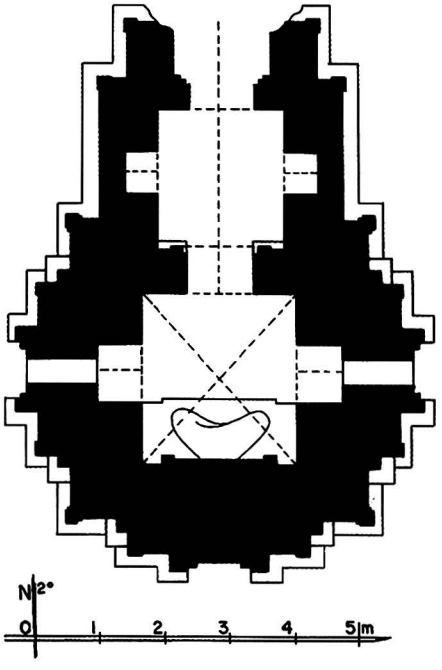
1798 a - Plan

5 present condition
- no maintenance.
- base disintegrated.
- east porch collapsed.
- upper parts badly damaged.

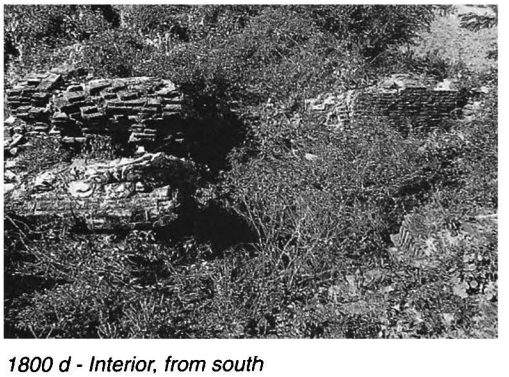
5 present condition
- ruined.
- only base of walls remains.
- ground floor cleared of debris.
- present height 0.95 m.

1800 c - Interior, pedestal of image, from south-east

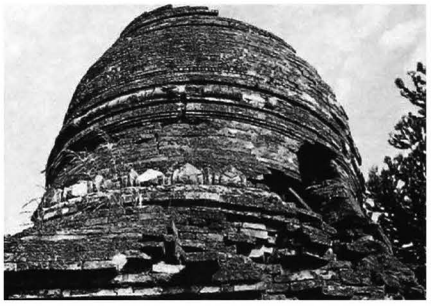
5 present condition
- no maintenance.
- base, terraces and upper parts badly damaged.

1801 d - From south-west

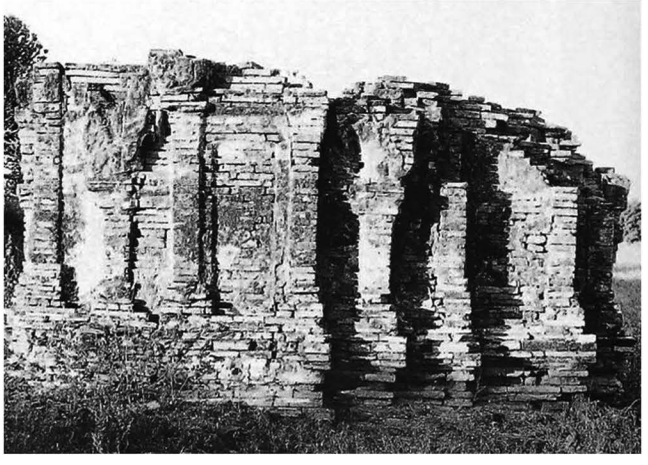
5 present condition
- half-ruined.
- vaults and upper parts collapsed.
- ground floor buried under debris.

1806 b - East face

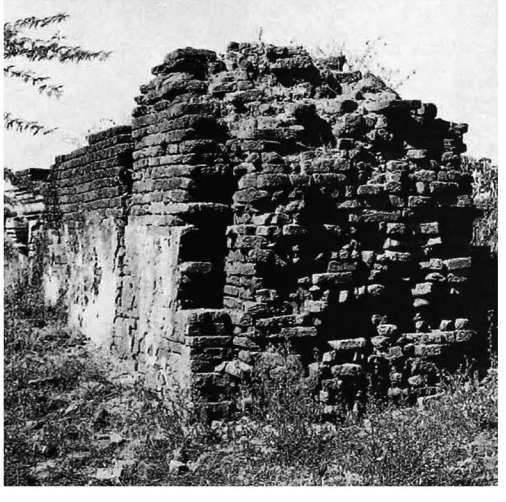
5 present condition
- ruined.
- only part of south wall remains.
- ground floor buried under debris.

1809 b - From south-east

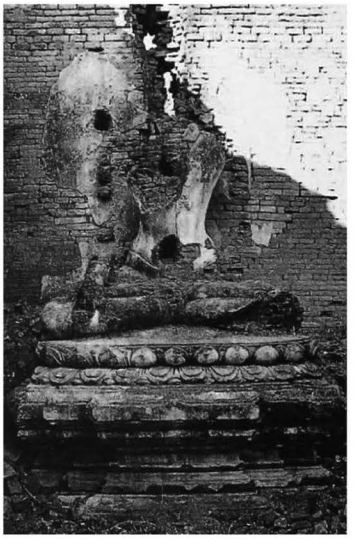
5 present condition
- half-ruined.
- base disintegrated.
- north wall collapsed.
- vaults and upper parts collapsed.
- structure badly cracked.
- ground floor cleared of debris.

6 image
- 1 seated Buddha, facing east
(damaged and headless).

1815 d - West wall and image, from east

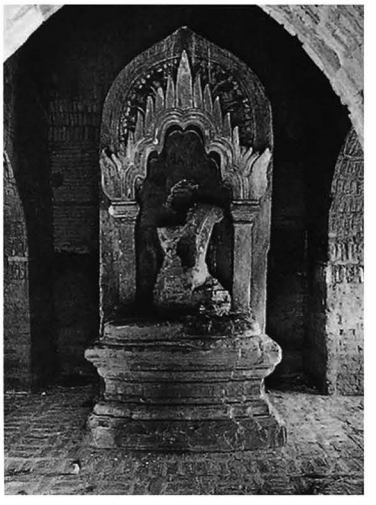
1817 e - Shrine, screen wall and image (1995), from east

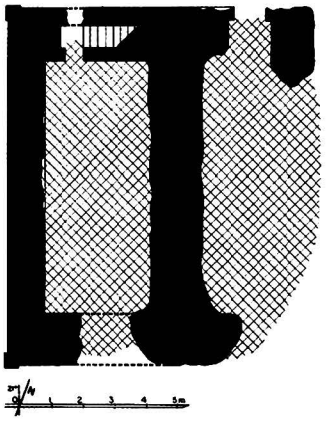
1819 a - Plan

5 present condition
- ruined.
- east wall, vaults and roof collapsed.
- ground floor buried under debris.

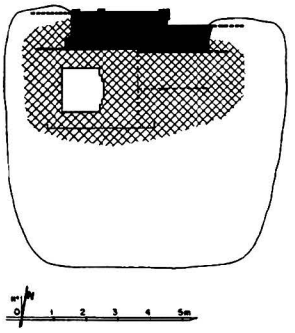
1820 a - Plan

5 present condition
- ruined.
- only part of north wall remains.
- vaults and upper parts collapsed.

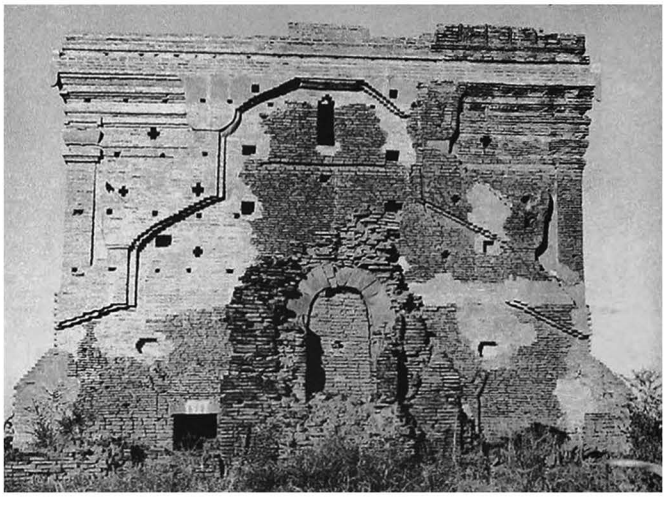
1821 b - East face

5 present condition
- maintained.
- repaired (Const. Corp.) 1982-83.

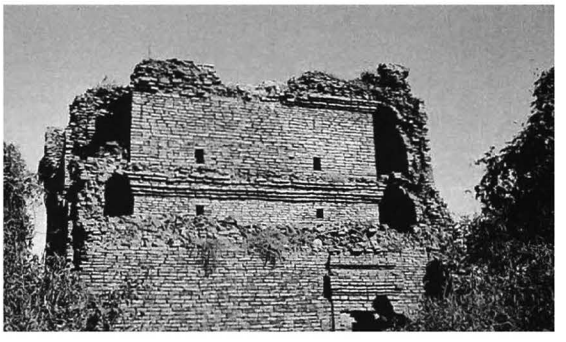
1822 c - South face (1975)

5 present condition
- vault and roof collapsed.
- badly damaged by the 1975 earthquake.
- repaired (Const. Corp.) 1982.

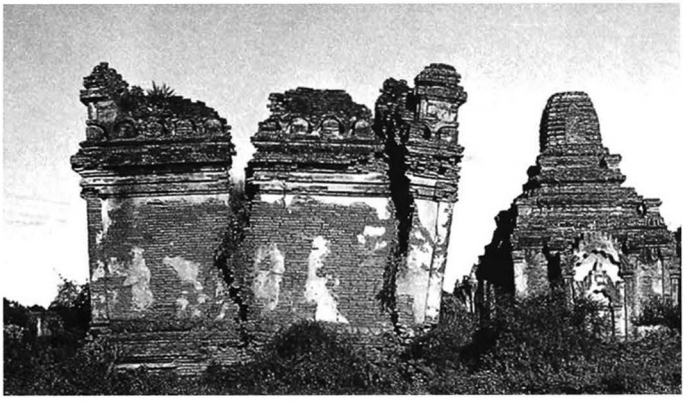
1828 c - East face, from south-east (1987), after repairs

5 present condition
- half-ruined.
- vaults and upper parts collapsed.
- structure badly cracked.
- repaired and buttressed (Arch. Dept.) 1984.

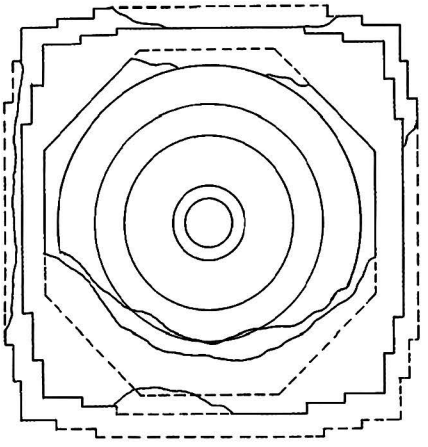
1 general description
- small single-storey temple ?

10 construction period
- estimated : **13th century AD (?).**

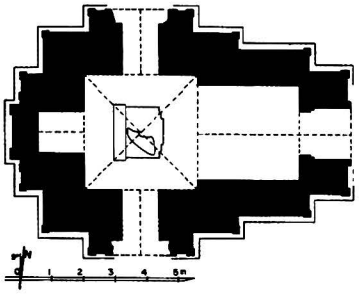
8 epigraphy
- 1 stone slab, prepared and polished but without inscription, 66 x 12, height = 96 cm.

east of NYAUNG U
south-east of **154 Kyauk-ku-umin**

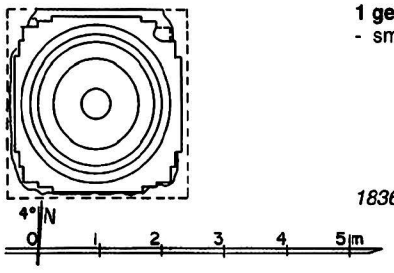
1 general description
- small single-storey temple.
- modern pavilion on west side.
- on a platform, together with **160**.

6 image
- 1 seated Buddha, facing west (previously gilded).

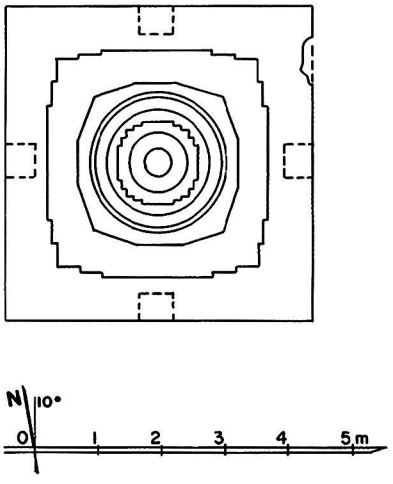
3 upper parts
- 1 square terrace with 1 corner stupa.
- 2 square terraces with 2 projections and corner urns.
- 1 octagonal terrace.
- circular bellshaped dome, slender spire and umbrella.

10 construction period
- estimated : **18th century AD.**

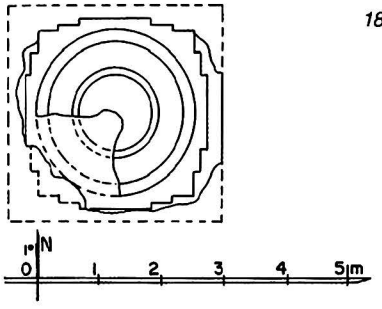
1 general description
- small octagonal stupa.
- at the centre of an enclosure wall with 1 gate on south.

7 decoration
- carved stone.

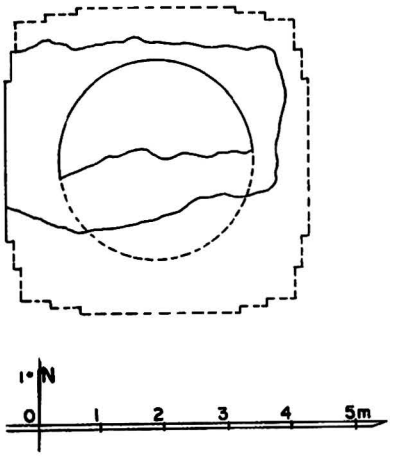
3 upper parts
- circular bellshaped dome, short conical spire and umbrella.

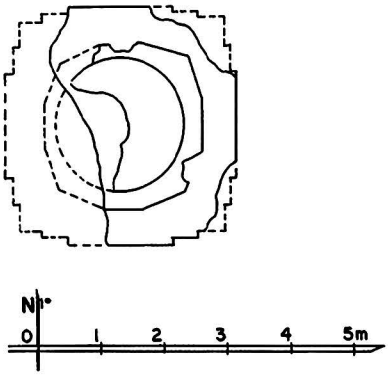
1848 a - Plan

5 present condition
- half-ruined.
- base and terraces disintegrated.
- upper parts nearly destroyed.

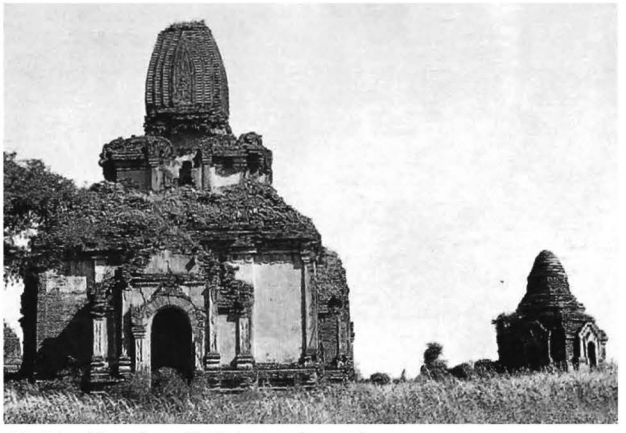
7 - *Decoration* : stucco mouldings (mostly on outside), mural paintings inside, with main features and estimate of percentage of original decoration remaining.

5 present condition
- vault of upper storey collapsed during the 1975 earthquake.
- repaired and strengthened (Arch. Dept.) 1993-94, under financial donation by Mr. Merrem (UNDP).

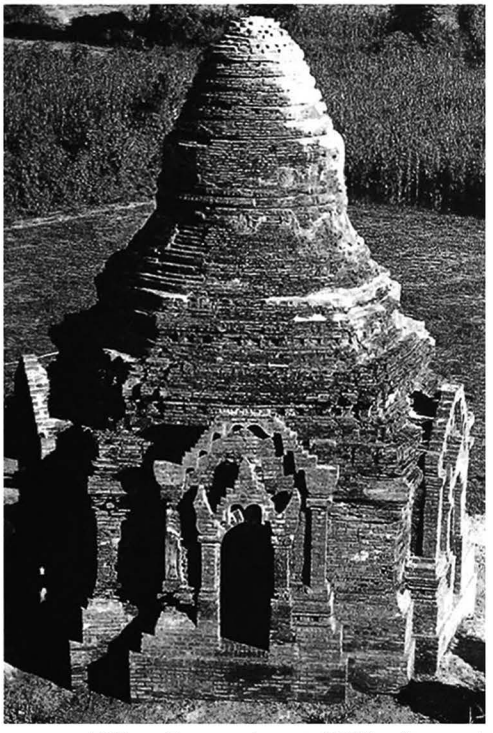
1853 e - From north-west (1983), after repair

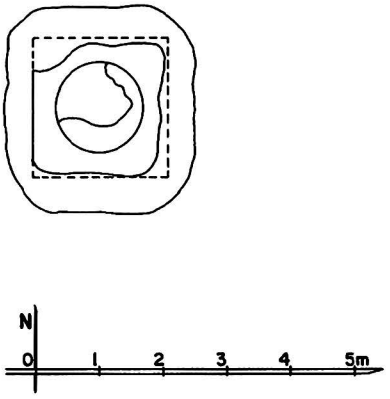
1856 a - Plan

5 present condition
- ruined.
- base and terraces disintegrated.
- upper parts destroyed.
- present height 1.80 m.

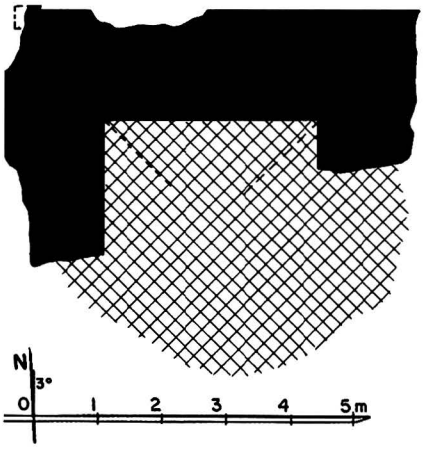
1857 a - Plan

5 present condition
- ruined.
- only north part remains.
- base disintegrated.
- vaults and upper parts collapsed.
- ground floor buried under debris.

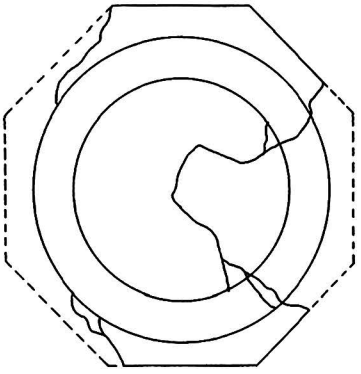
1858 a - Plan

5 present condition
- half-ruined.
- base and terraces disintegrated.
- upper parts nearly destroyed.

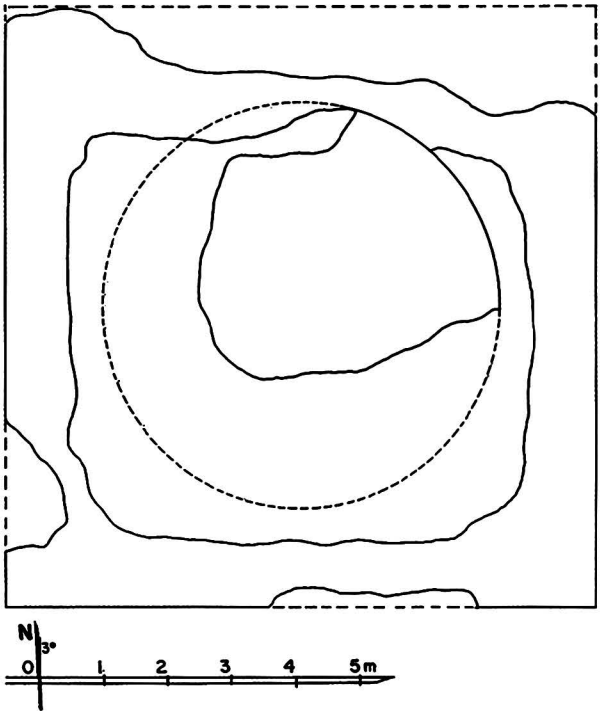
1859 a - Plan

5 present condition
- ruined.
- base and terraces disintegrated.
- upper parts nearly destroyed.

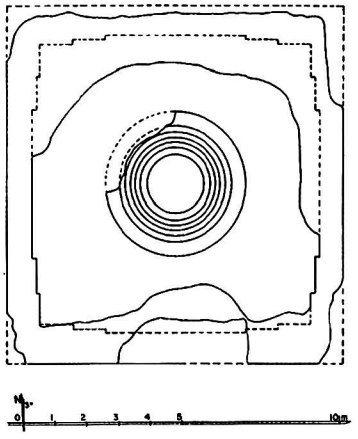
1860 a - Plan

5 present condition
- half-ruined and endangered.
- upper parts damaged.

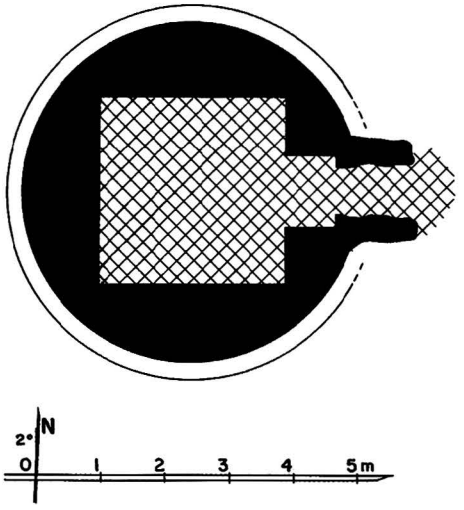
1861 a - Plan

5 present condition
- ruined.
- vaults and upper parts collapsed.
- ground floor buried under debris.

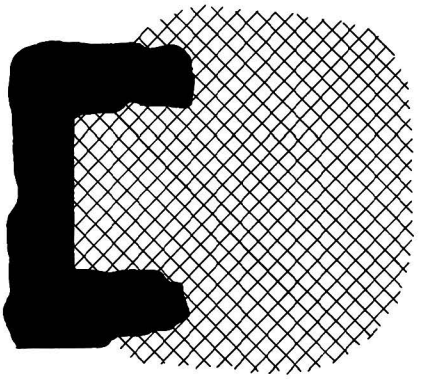
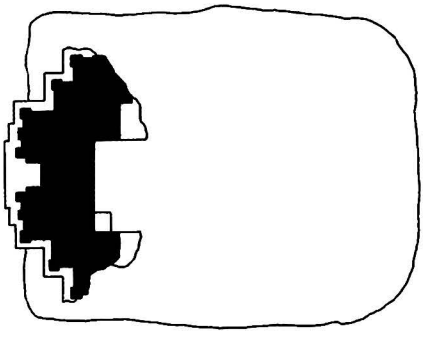
1862 a1 - Ground-floor plan

5 present condition
- ruined.
- only west part remains.
- buttressed (Arch. Dept.) 1984.

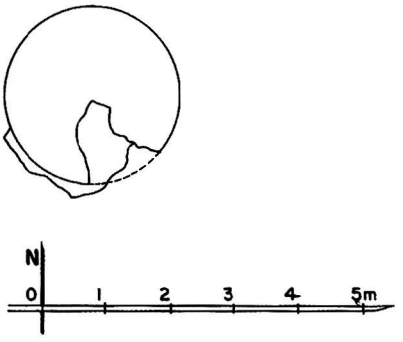
1863 a - Plan

5 present condition
- half-ruined.
- base and terraces disintegrated.
- upper parts badly damaged.

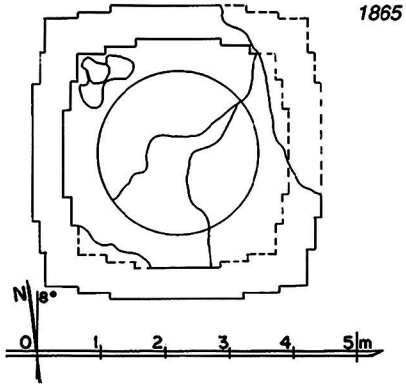
1865 a - Plan

5 present condition
- north-east corner disintegrated.
- repaired (Arch. Dept.) 1984.

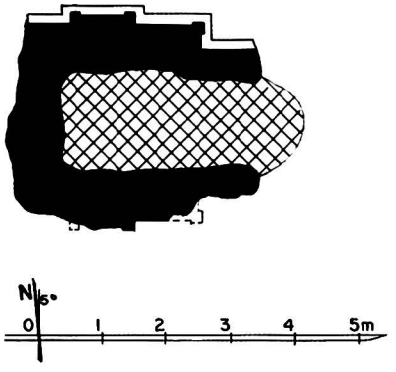
1867 a - Plan

5 present condition
- ruined.
- vaults and upper parts collapsed.
- ground floor buried under debris.

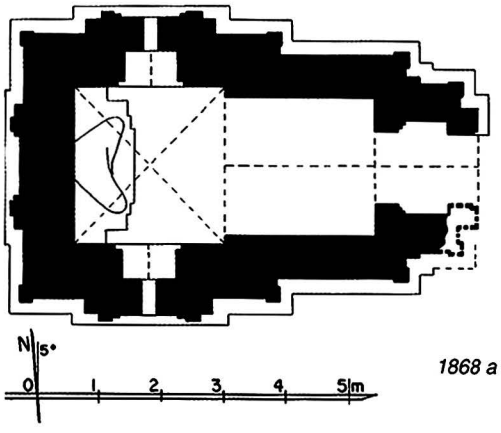
1868 a - Plan

5 present condition
- no maintenance.
- east porch collapsed.
- structure cracked.
- upper parts badly damaged.

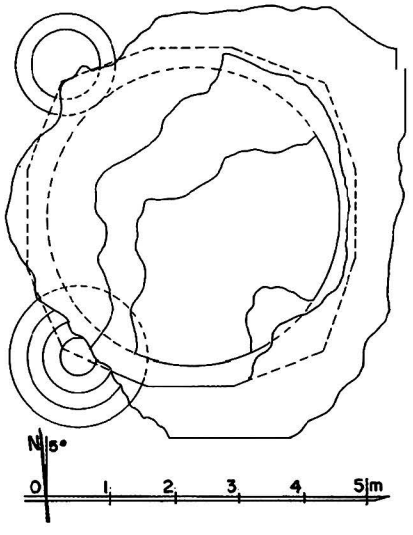
1870 a - Plan

5 present condition
- half-ruined.
- base and terraces disintegrated.
- upper parts nearly destroyed.

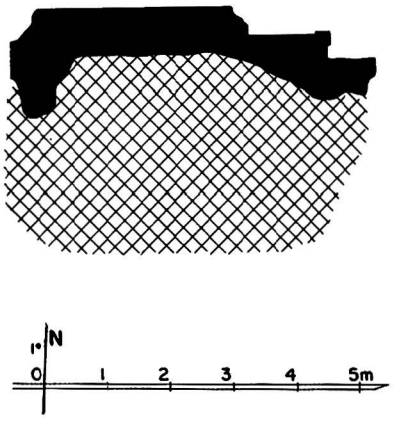
1871 a - Plan

5 present condition
- ruined.
- only north part remains.
- vaults and upper parts collapsed.
- ground floor buried under debris.
- present height 1.80 m.

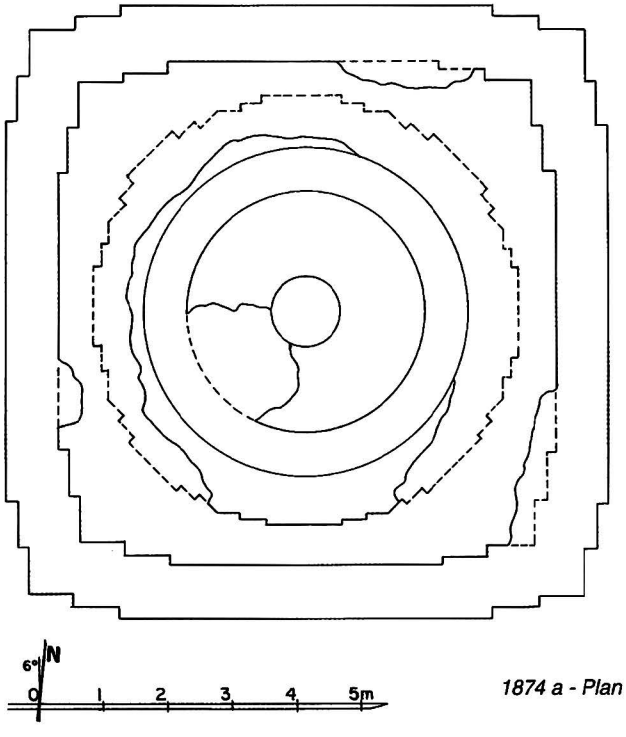
1874 a - Plan

5 present condition
- no maintenance.
- base and terraces badly cracked.
- upper terrace disintegrated.
- upper parts badly damaged.

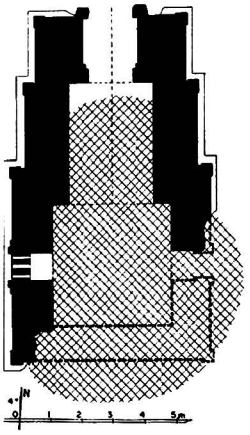
1875 a - Plan

5 present condition
- half-ruined.
- south-east corner, vaults and upper parts collapsed.
- ground floor buried under debris.

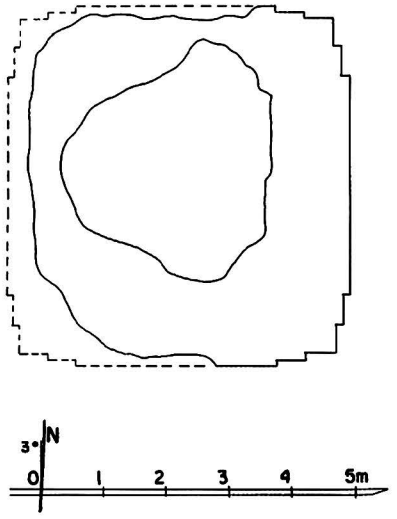
1877 a - Plan

5 present condition
- ruined.
- base and terraces disintegrated.
- upper parts destroyed.

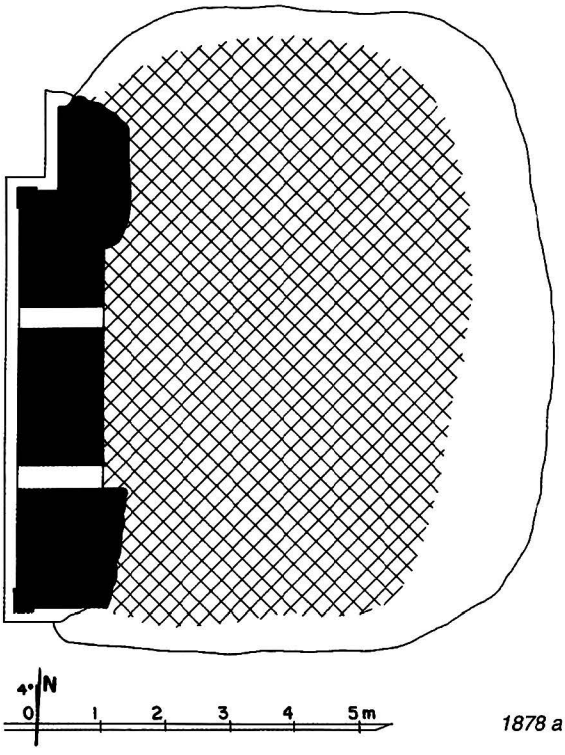
1878 a - Plan

5 present condition
- ruined.
- only west wall remains.
- vaults and upper parts collapsed.
- ground floor buried under debris.

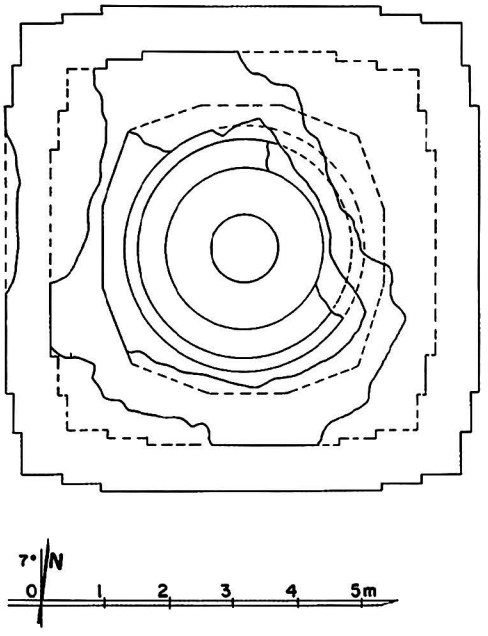
1880 a - Plan

5 present condition
- no maintenance.
- terraces disintegrated.
- upper parts badly damaged.

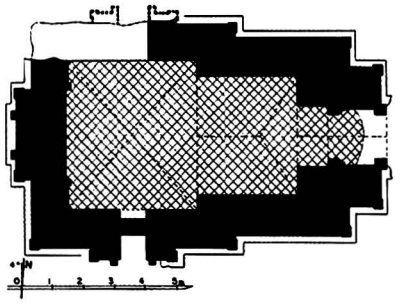
1881 a - Plan

5 present condition
- ruined.
- base disintegrated.
- part of north wall collapsed.
- vaults and upper parts destroyed.
- ground floor buried under debris.

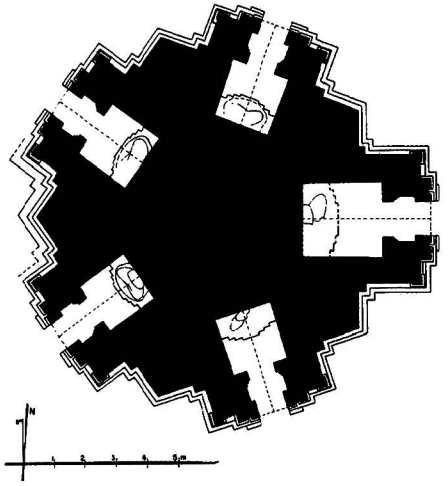
1883 a - Plan

5 present condition
- no maintenance.
- east forepart collapsed.
- upper parts badly damaged.

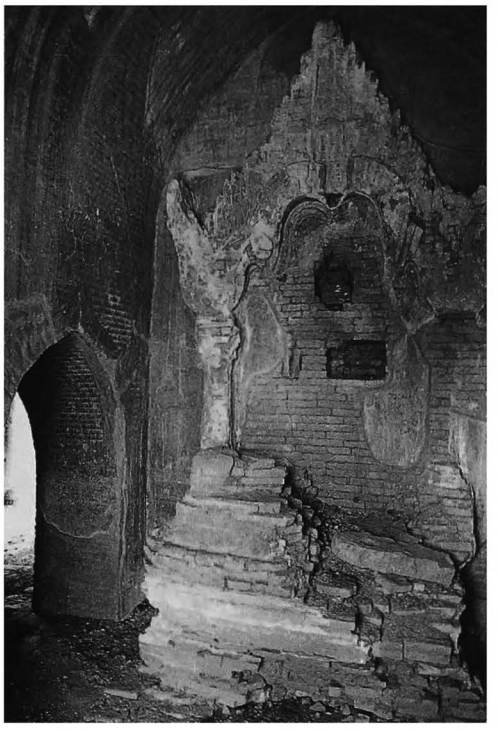
1884 e - East shrine, image and corridor, from north-east

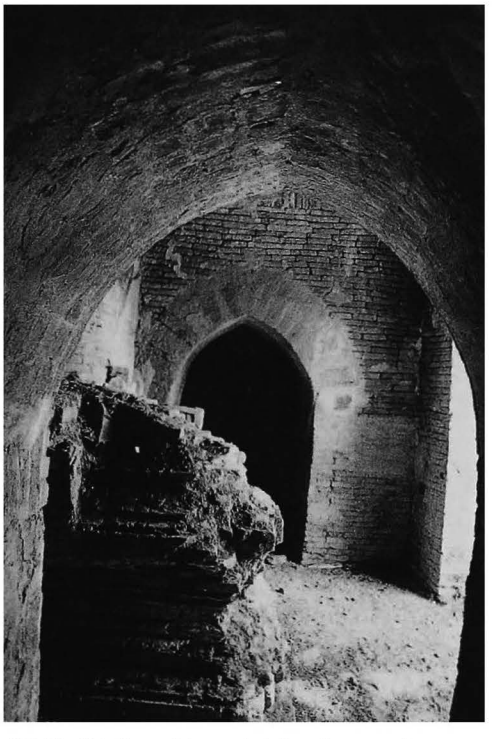
1884 f - South corridor and shrine, from west

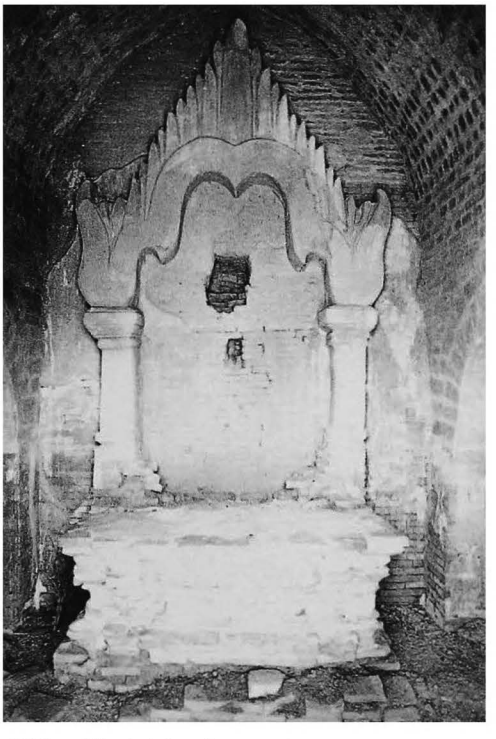
1884 g - West shrine, from west

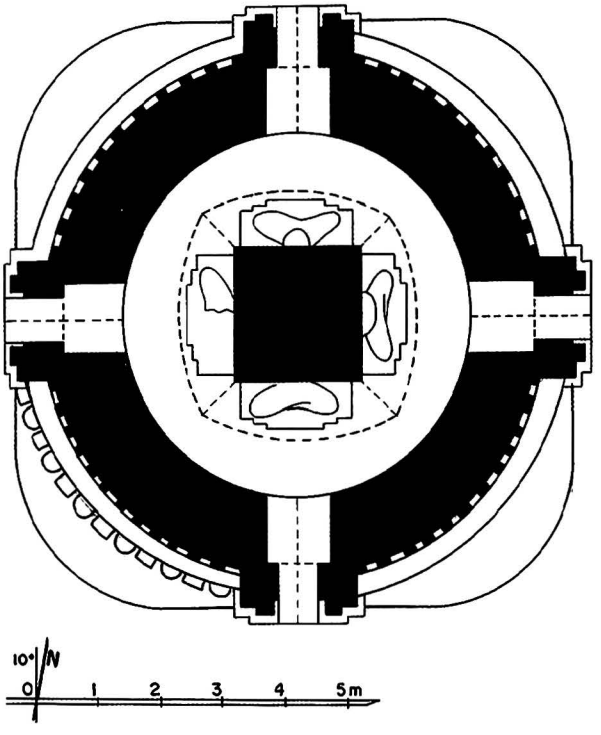
1885 a - Plan

5 present condition
- repaired and strengthened (Const. Corp.).

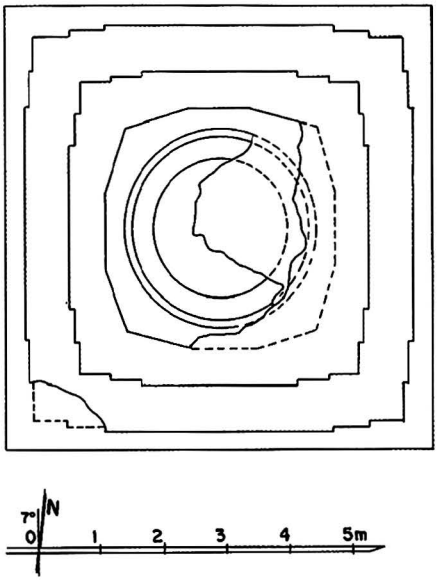
1886 a - Plan

5 present condition
- half-ruined.
- base and terraces disintegrated.
- upper parts badly damaged.

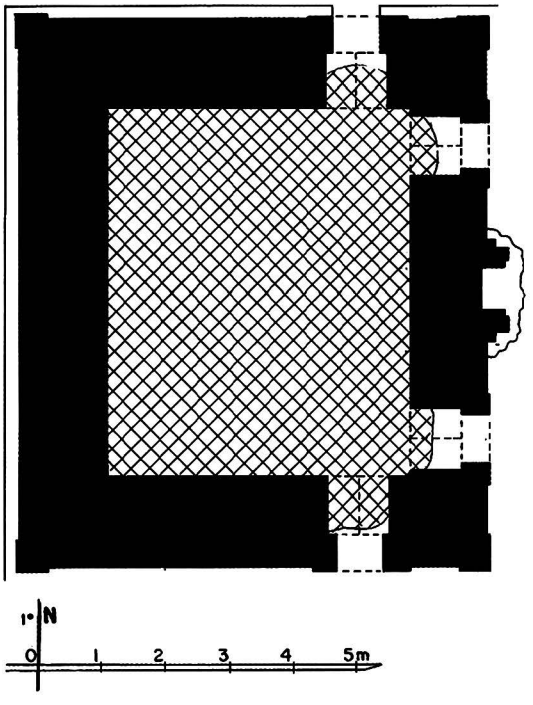
1887 a - Plan

5 present condition
- ruined.
- vault and roof collapsed.
- ground floor buried under debris.

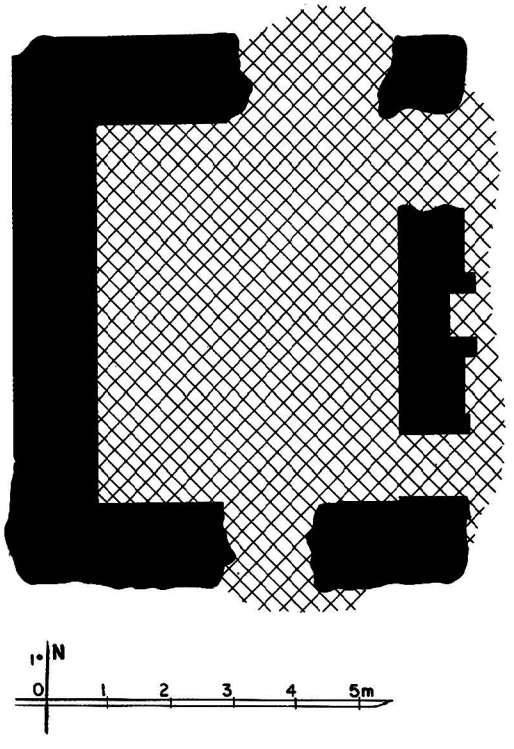
1888 a - Plan

5 present condition
- ruined.
- vault and roof collapsed.
- ground floor buried under debris.

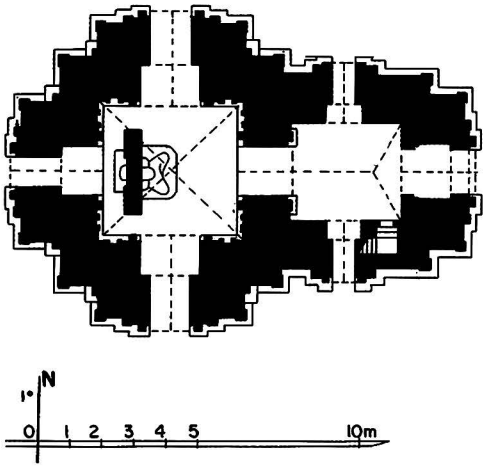
1889 a - Plan

5 present condition
- base disintegrating.
- upper parts badly damaged, partly repaired 1984.

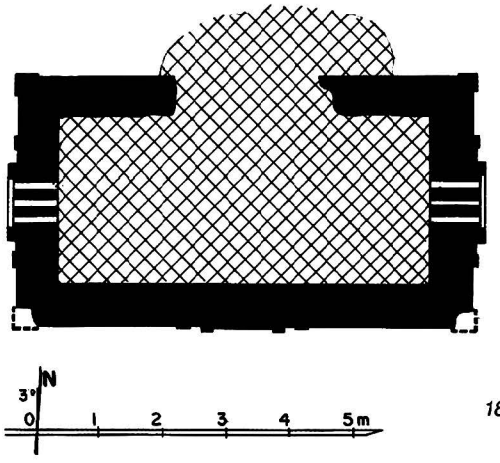
1891 a - Plan

5 present condition
- half-ruined.
- vaults and roof collapsed.
- north porch destroyed.
- ground floor buried under debris.

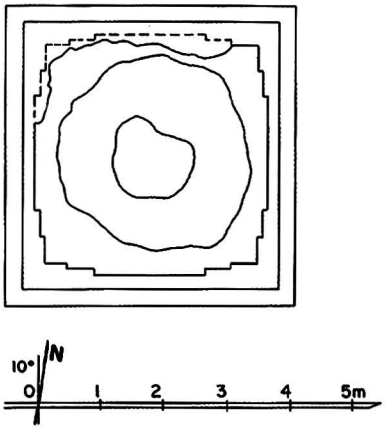
1893 a - Plan

5 present condition
- no maintenance.
- upper parts destroyed.

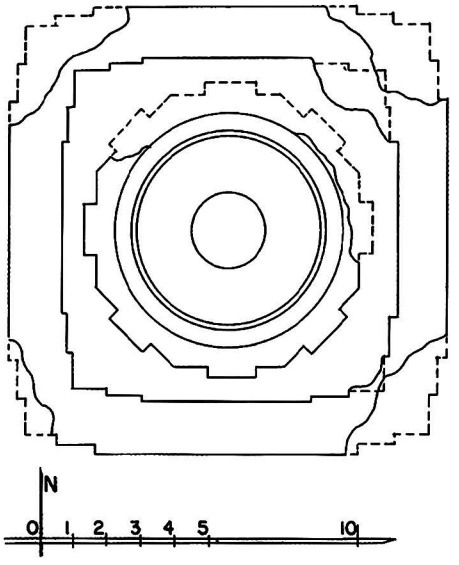
1894 a - Plan

5 present condition
- no maintenance.
- base and terraces disintegrated.
- upper parts badly damaged.

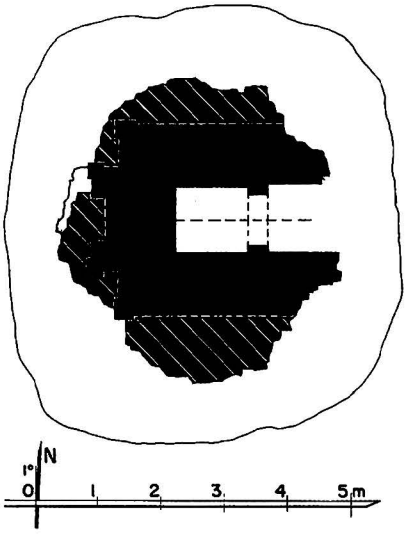
1896 a - Plan

5 present condition
- half-ruined.
- base and walls disintegrated.
- east porch collapsed.
- upper parts nearly destroyed.

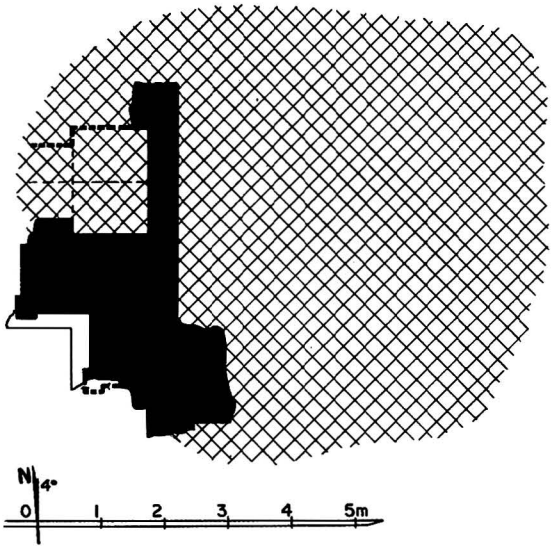
1897 a - Plan

5 present condition
- ruined.
- only part of west side remains.
- vaults and upper parts collapsed.
- ground floor buried under debris.

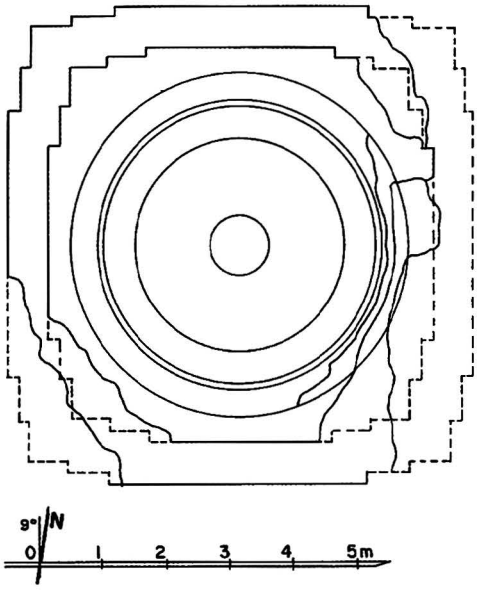
1900 a - Plan

5 present condition
- no maintenance.
- base and terraces disintegrated.
- upper parts badly damaged.

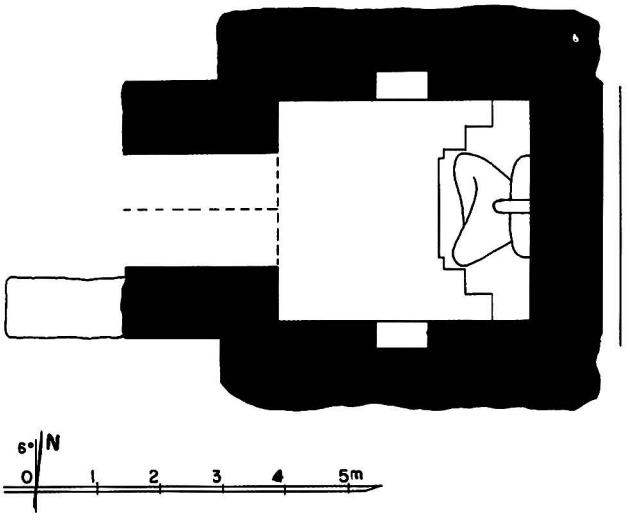
1901 a - Plan

5 present condition
- ruined.
- vaults and upper parts collapsed.
- west porch destroyed.
- ground floor cleared of debris.

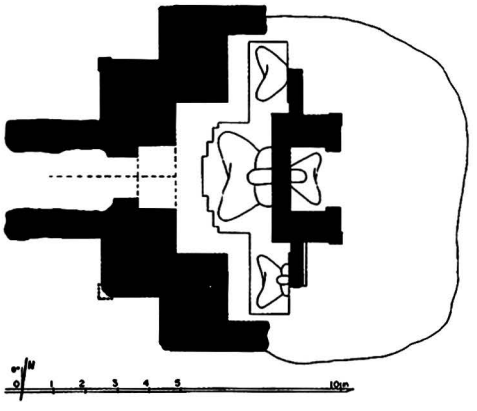
1902 a - Plan

5 present condition
- ruined.
- vaults and upper parts collapsed.

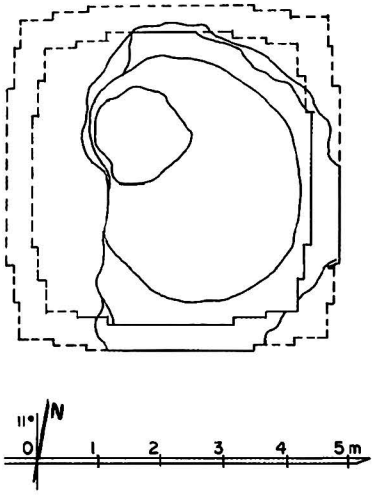
1903 a - Plan

5 present condition
- half-ruined.
- base and terraces disintegrated.
- upper parts destroyed.

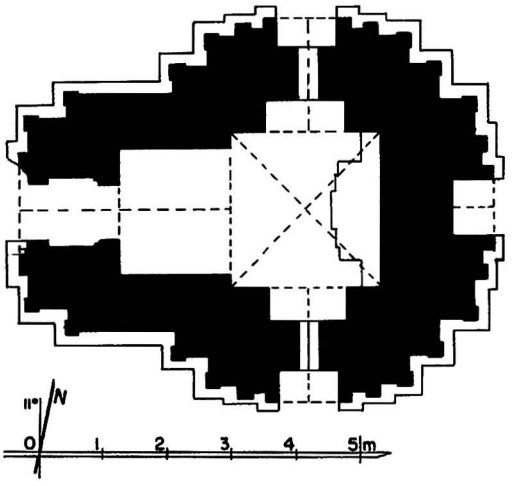
1904 a - Plan

5 present condition
- no maintenance.
- base disintegrated.
- structure cracked.
- upper parts badly damaged.

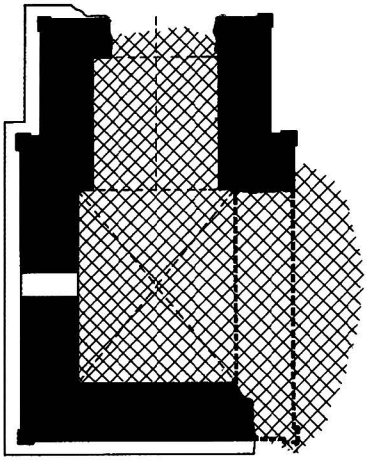
1906 a - Plan

5 present condition
- ruined.
- east wall, vaults and upper parts collapsed.
- ground floor buried under debris.

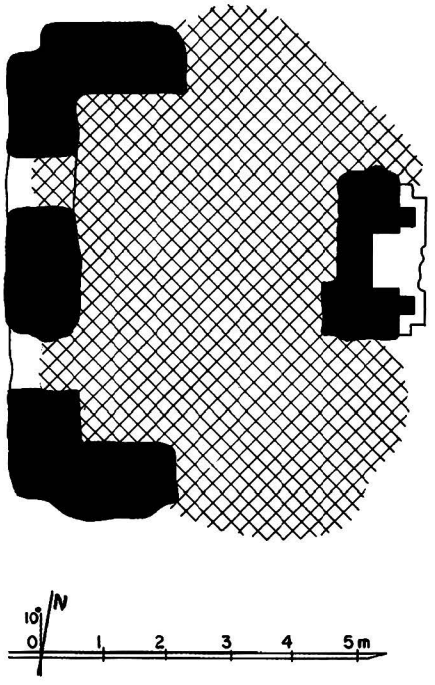
1911 a - Plan

5 present condition
- ruined.
- south and north walls, vaults and roof collapsed.
- ground floor buried under debris.

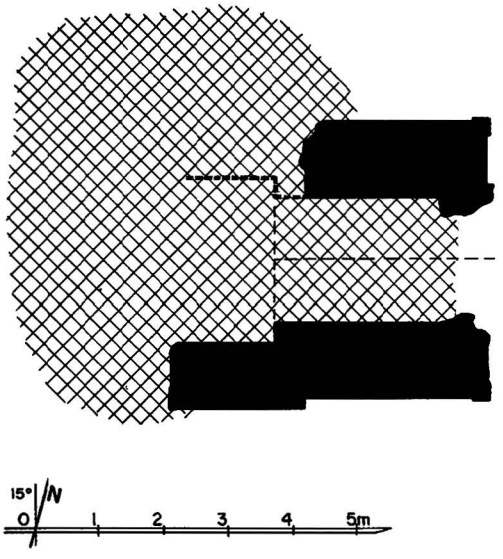
1912 a - Plan

5 present condition
- ruined.
- only east part remains.
- vaults and upper parts collapsed.
- ground floor buried under debris.

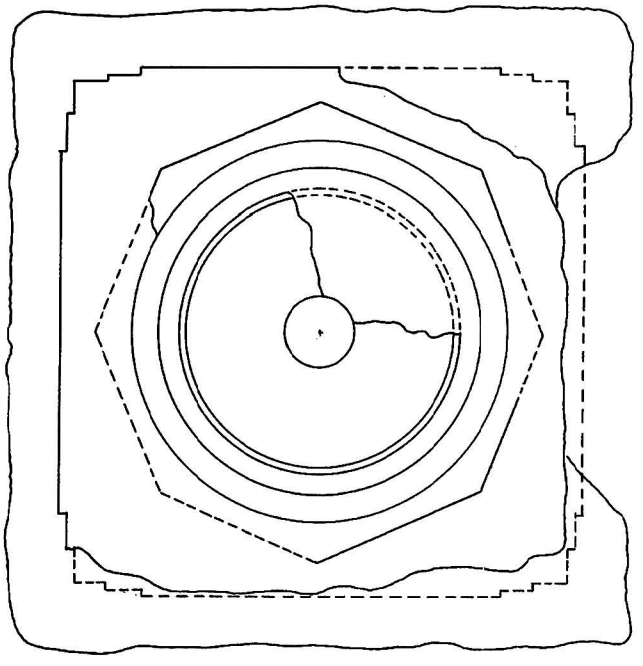
1916 a - Plan

5 present condition
- no maintenance.
- terraces disintegrated.
- upper parts badly damaged.

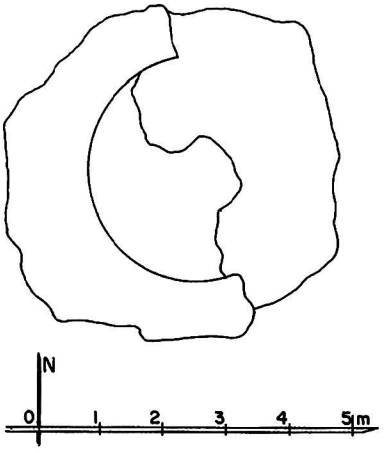
1918 a - Plan

5 present condition
- ruined.
- terraces disintegrated.
- present height: 2.40 m.
- upper parts destroyed.

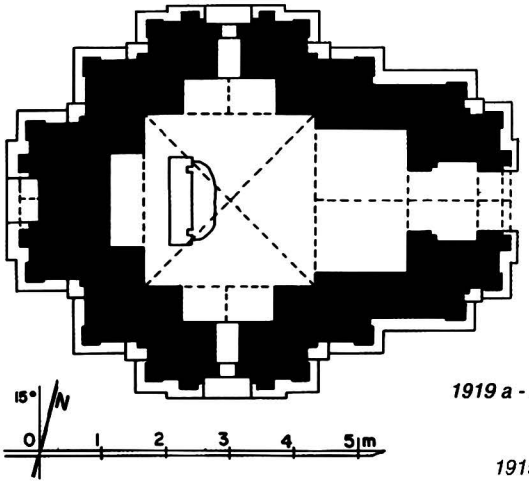
1919 a - Plan

5 present condition
- no maintenance.
- base disintegrated.
- east porch destroyed.
- upper parts badly damaged.

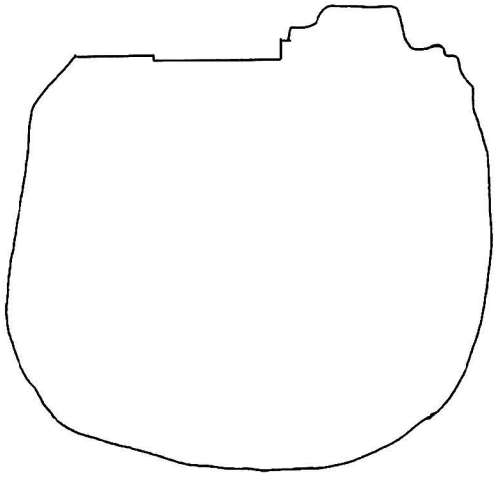
1922 a - Plan

5 present condition
- only base of north wall remains.
- height: approx. 2.00 m.

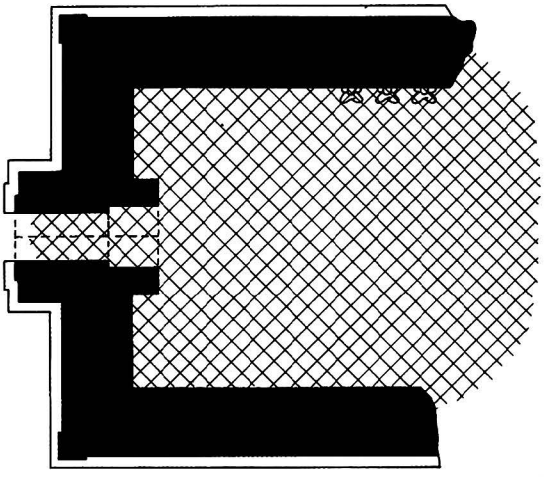
1923 a - Plan

5 present condition
- ruined.
- only west part remains.
- vaults and upper parts collapsed.
- ground floor buried under debris.

6 images
- 3 seated Buddhas, facing south (damaged).

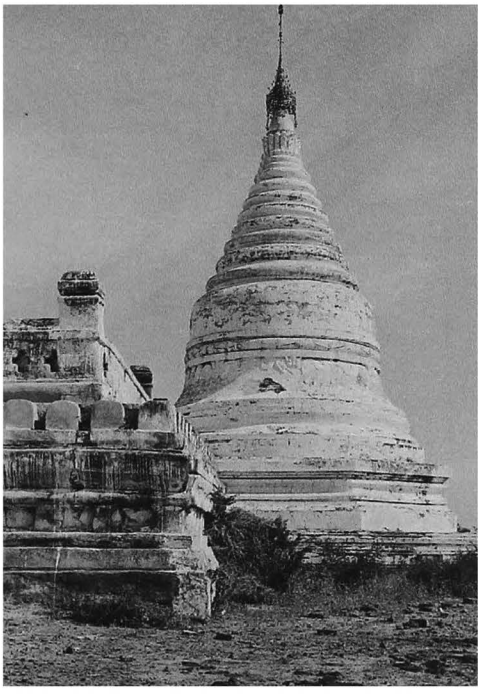
1928 c - West face

5 present condition
- maintained and whitewashed.

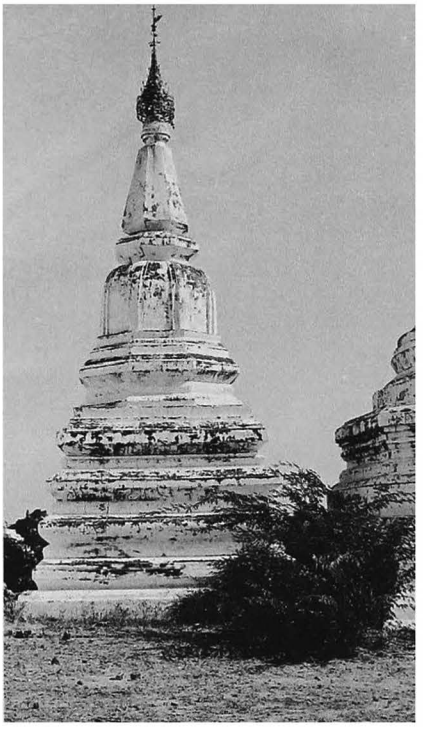
5 present condition
- maintained and whitewashed.

1929 b - From north-east,
between 1930 and 1928, recently whitewashed (1990)

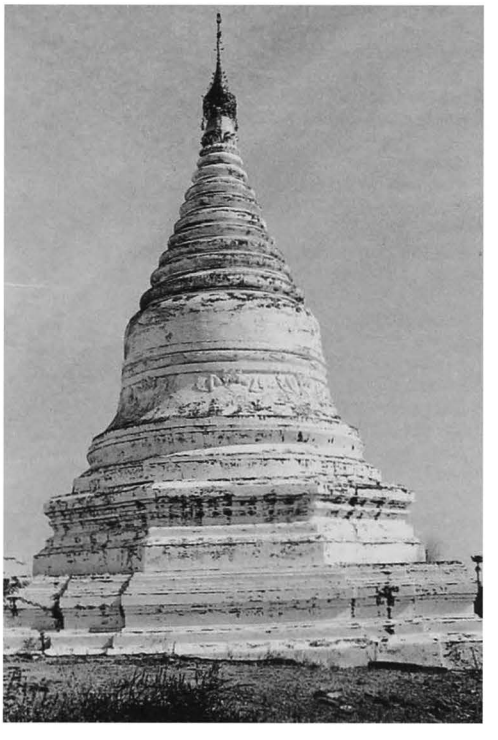
1930 b - West face (1987)

5 present condition
- maintained and whitewashed.
